EXECUTIVE SUMMARY

NASA and the Russian Space Agency (RSA) are involved in a cooperative venture in which the Shuttle will rendezvous and dock with the Mir Space Station during several missions from 1995 to 1998. This sequence of nine missions will serve as a precursor to the two nations' involvement in the International Space Station. These joint missions provide NASA scientists and engineers an opportunity to study the orbital, dynamic, and environmental conditions of long duration spacecraft, as well as develop evaluation and risk mitigation techniques which have direct application to the International Space Station.

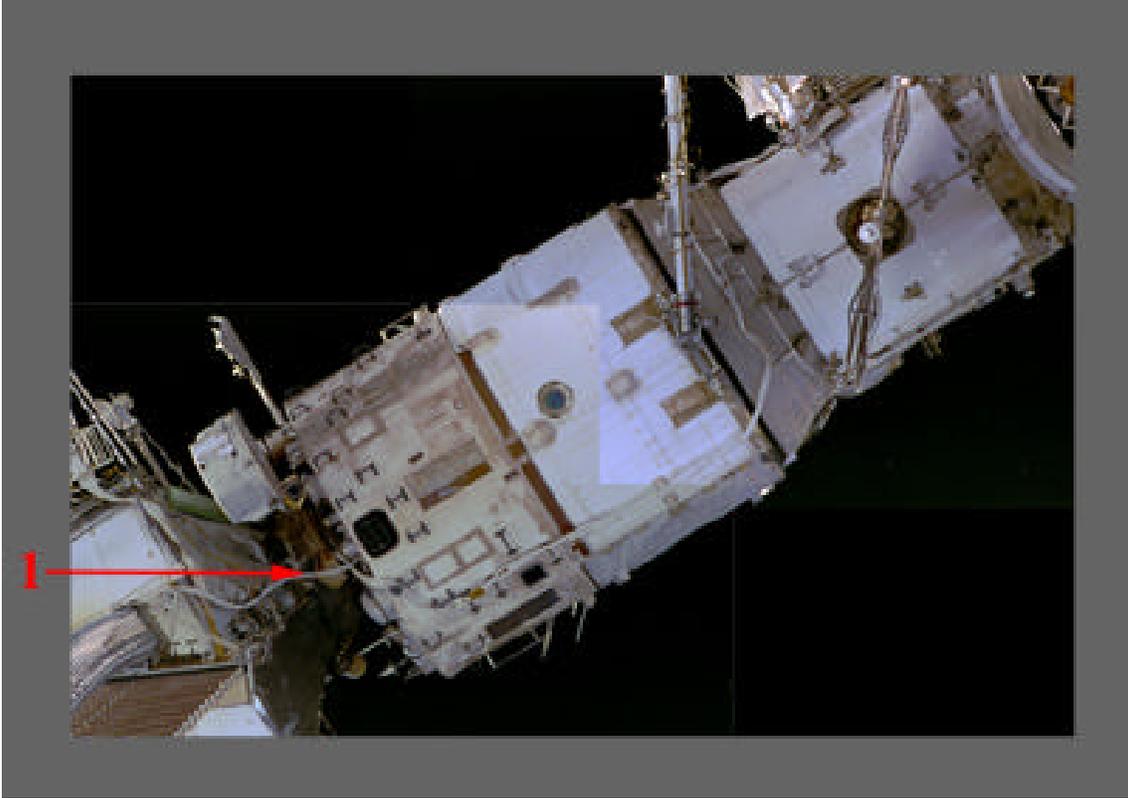
Figure 2.5 Base Block

Figure 2.5 is a mosaic of two photographs which have been combined to show the power cable [1] which appears to originate from the attach point of the Base Block SP#3 (in the upper right-hand corner of the frame) and extends to the attach point of the CSA on Kvant (in the lower left-hand corner of the frame).

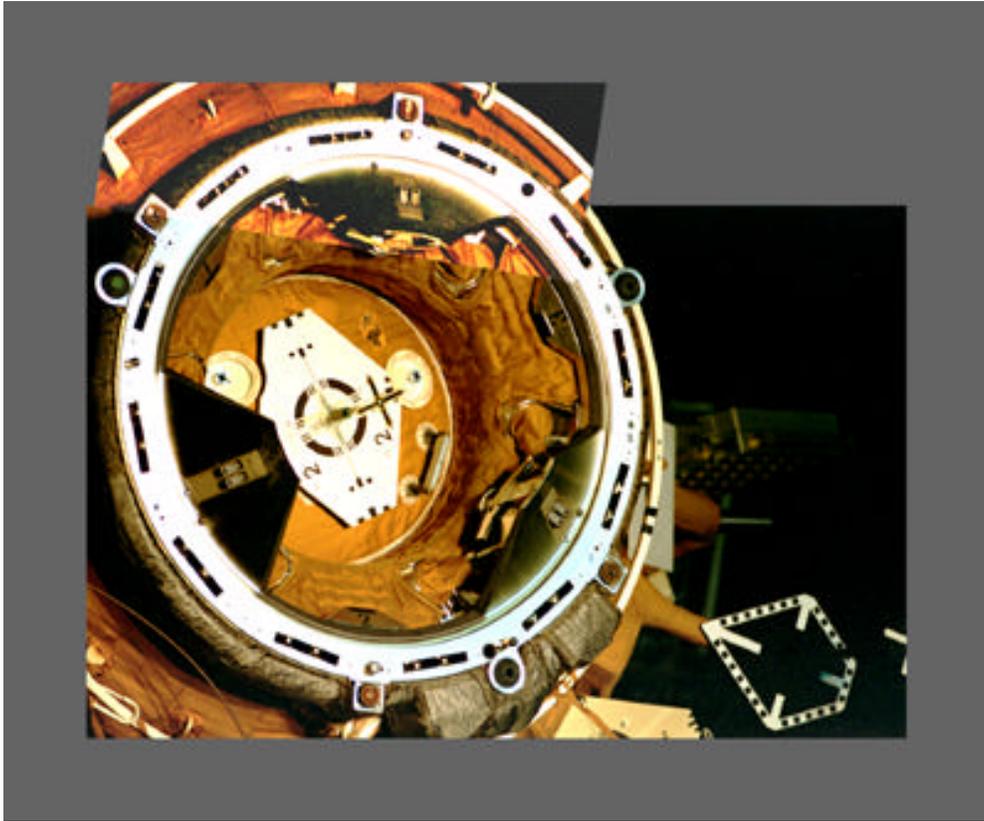
Figure 4.3 Composite Image of Docking Mechanism during Approach

Although the docking ring and the target are clearly visible, the video imagery is not of sufficient quality (due to poor lighting) to perform an assessment of the docking mechanism during the docking phase. However, the close-up images taken with the 35 mm film camera during approach show the structural latches, capture latches, alignment guides, laser retroreflectors, electrical socket plugs, and the centerline target backplate and stand-off target cross to be in excellent condition. A composite image of the full docking ring has been formed from two separate images and is shown as Figure 4.3.

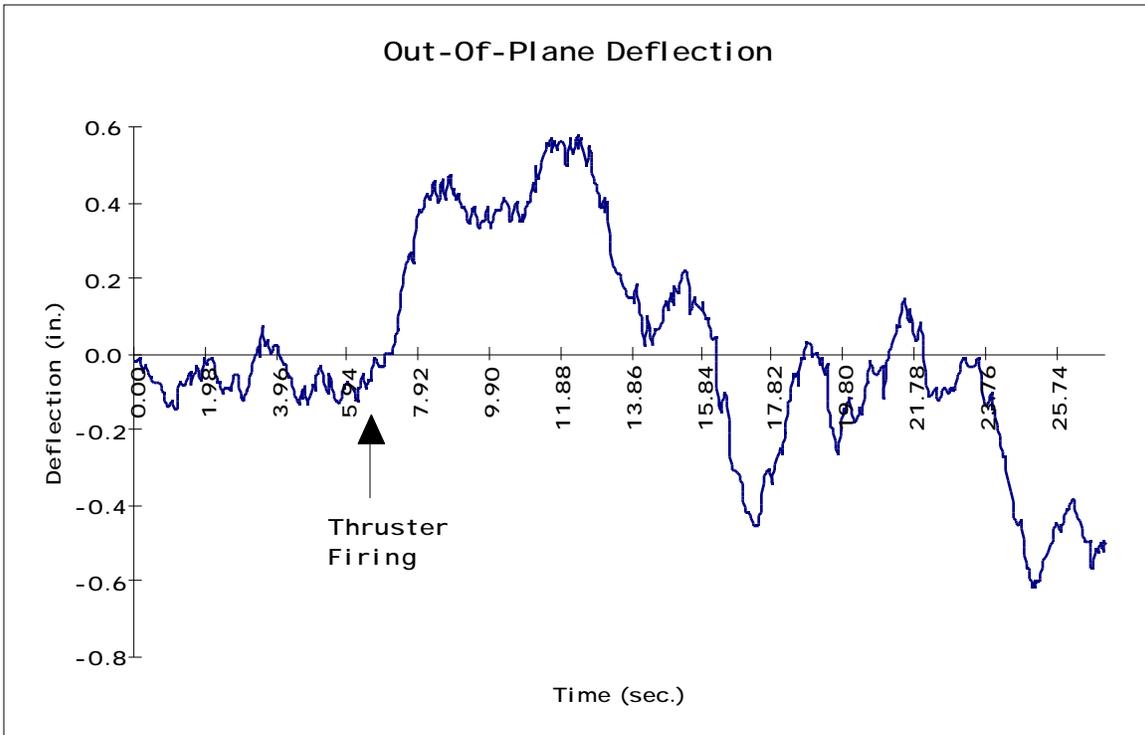
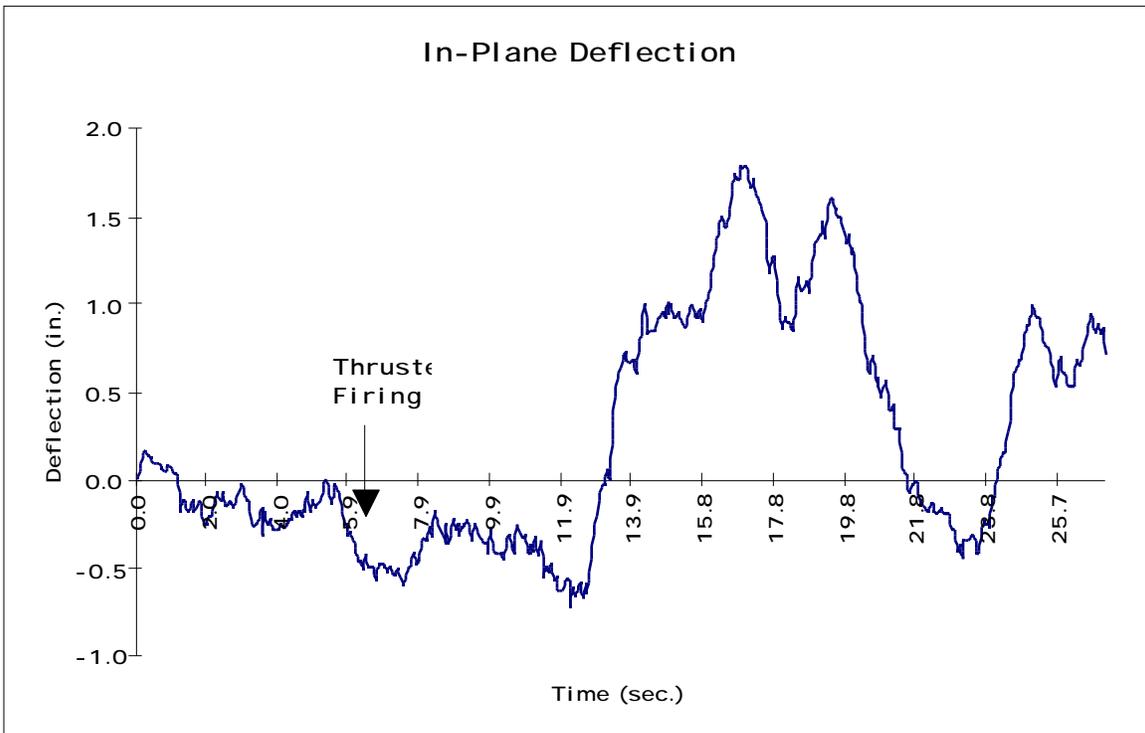
In order to smooth the noise due to fluctuations in placement of data points, a moving average of the deflection data was calculated over 15 frames (1 second). These results are shown in Figures 5.3 and 5.4 for the out-of-plane and in-plane motions as a function of time. The peak-to-peak deflections were approximated from these smoothed curves as 1.3 inches (3 pixels) for out-of-plane motion and 2.2 inches (4 pixels) for in-plane motion. Due to the noise in the data, a Fast Fourier Transform (FFT) was applied to determine the dominant frequency. The graphs of the FFT's for the out-of-plane and in-plane data are shown in Figures 5.5 and 5.6. To emphasize the frequency of the motion and remove the frequency data associated with the sampling rate of the data, a small section of the fourier transformed data is plotted. The dominant frequency for both the in-plane and out-of-plane motion is approximately 0.4 Hz. The structural model predicts frequencies at approximately 0.15 and 0.4 Hz. To more accurately determine the amplitude and frequency from video, data with a greater signal-to-noise ratio must be acquired.

- The PLB camera field-of-view should be smaller to focus on a smaller section of the solar array. The amplitude of the array motion would then span more pixels in the video frame. Small amplitudes could then be easily measured as they would show up as motion over a range of several pixels.
- IRIG timing must be recorded onto the tapes which contain the video.
- The allocated time for the crew to perform set-up of the cameras must be scheduled during a day pass.

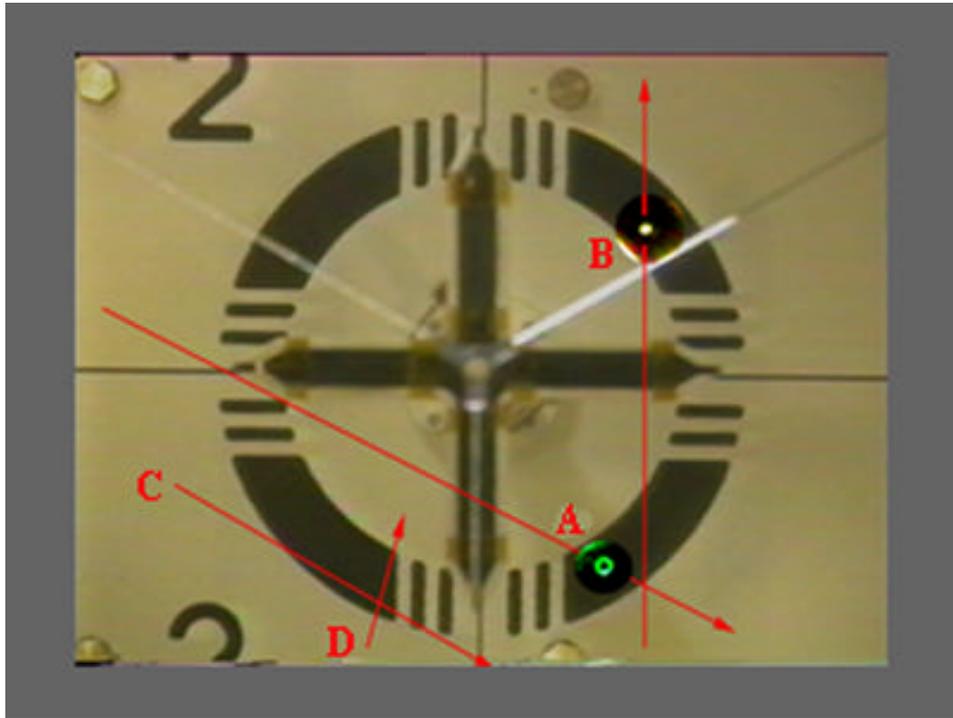
Figure 6.3 Debris Observed Internal to ODS during Soft Dock

Also, at the time of docking, several pieces of small debris were observed within the confines of the ODS by the ODS centerline TV (CLTV) camera. Figure 6.3 is a composite image which shows two of these pieces of debris, which appear to be of different origin and composition. A ring-shaped debris traverses from upper-left to lower-right as indicated by the arrow. The video shows this ring-shaped debris traverses between the ODS CLTV camera and the target alignment wire within the ODS. Several other less prominent ring-shaped debris traverse in a similar direction as shown by the arrow C. The second debris, item B, does not appear to be ring-shaped and traverses in a direction from bottom to top in Figure 6.3. Other debris of similar appearance also traverse in a similar direction as indicated by the arrow D.

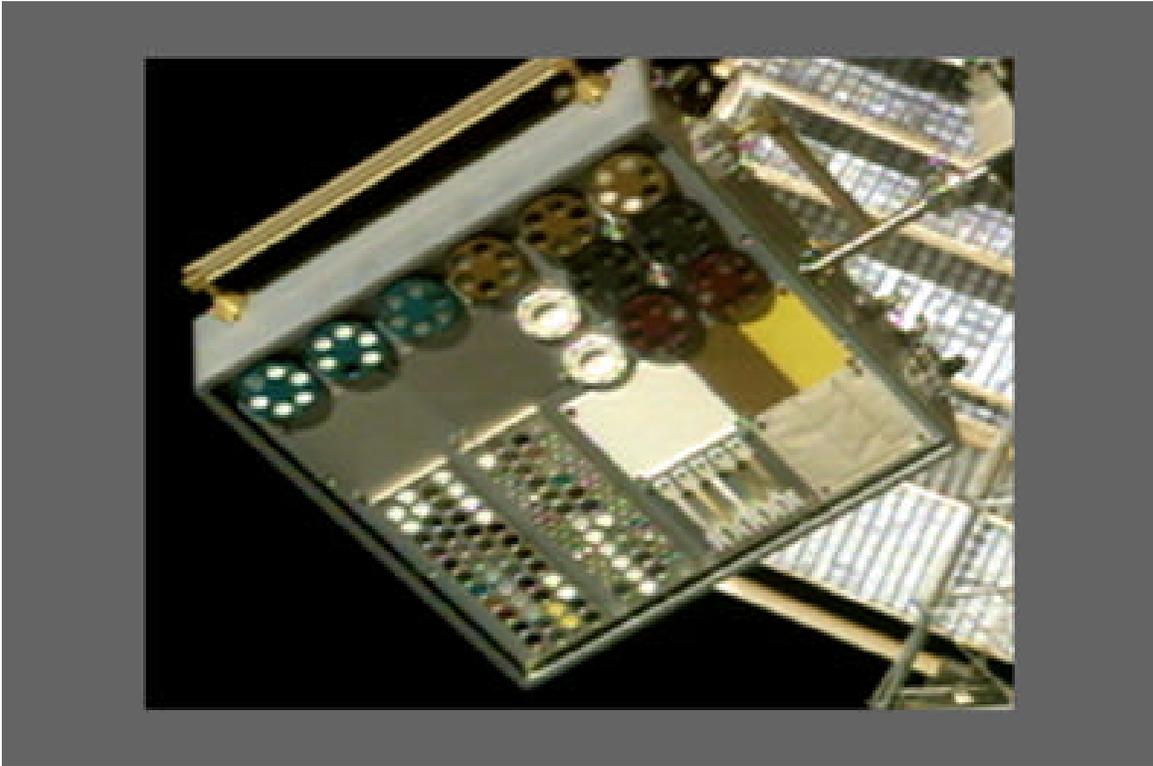
Figure 7.2 Video Image of POSA Front Panel

Shuttle is docked to Mir. The video images from PLB camera D, and still photographs from the Shuttle aft flight deck window, are sufficient to show no significant damage or discoloration on the Shuttle facing panel of POSA. Figure 7.2 shows an image of POSA taken with the PLB Camera D during the video survey.

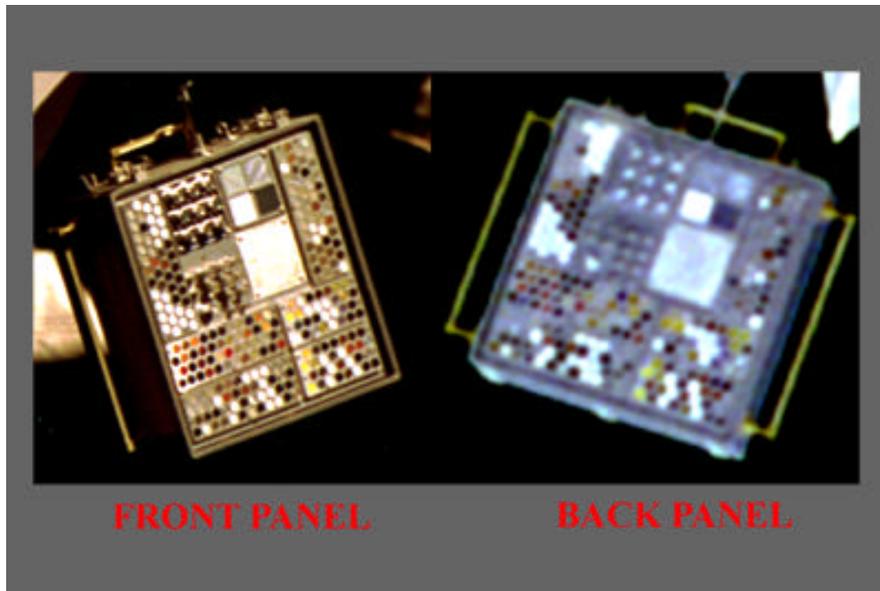
Figure 7.3 Still Photographs of POSA II Front and Back Panels

Figure 7.3 shows both the front panel of POSA II as obtained during approach and the back panel as obtained during the fly-around. Both views are digitally enlarged and contrast enhanced. The back panel view was extracted from the Figure 7.1. No significant damage or discoloration to either POSA II panel is detectable.

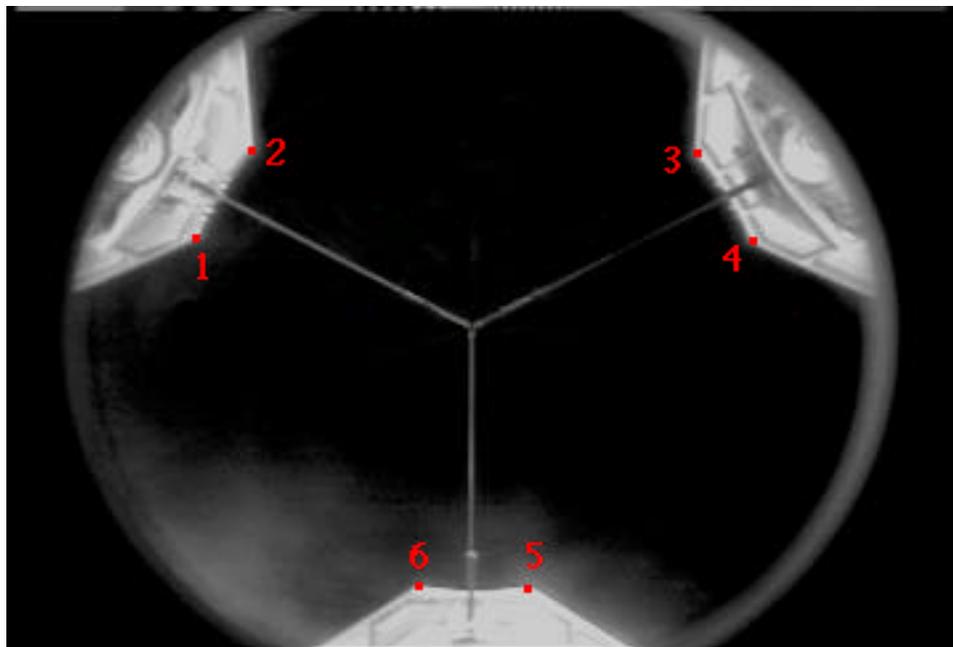
Figure 8.2 ODS Features Used in Alignment Analysis

Positional misalignment of the centerline camera was determined from a frame of video captured during the Shuttle's approach to Mir. Figure 8.2 shows this frame of video with the Mir omitted for clarity. The alignment guides of the ODS and the alignment washer are seen in this frame of video. The alignment washer is a small object at the intersection of supporting wires which extend from the petals. Three steps were taken to determine the offset of the centerline camera and alignment washer in relation to the center of the ODS.

In addition to the positional misalignment, the rotational misalignment (roll) of the centerline camera was calculated from the view shown in Figure 8.2. Points 1 through 6 were used to define parallel lines in the image by creating line segments from points 2-3, 1-4, and 5-6. If the centerline camera shows no rotational misalignment, these lines will be perfectly parallel to the X-axis of the image. This was not the case for STS-81. The X and Y intercepts of these parallel lines were determined, and the angles between these parallel lines and the X-axis of the image were used to determine the roll of the camera. Three measurements were made using the six tips of the ODS petals resulting in an average camera roll of $-0.38^\circ \pm 0.25^\circ$ in Shuttle Dynamic Body Coordinates (the coordinate system in which yaw, pitch, and roll are provided to the crew). The dominant contribution to the standard error in this result is the mounting tolerance ($\pm 0.25^\circ$) between the ODS base and the Shuttle Androgynous Peripheral Docking Unit (APDU) alignment guide ring to which the petals are attached. The standard error due to image measurements is ± 0.02 .

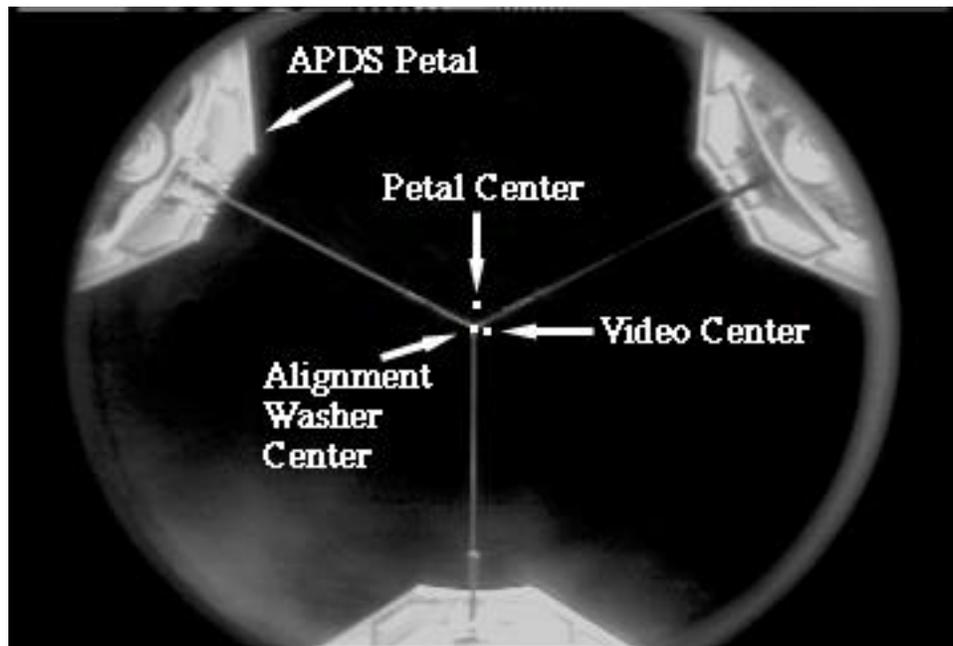
Figure 8.3 The Relative Centers of the ODS as Computed from the Alignment Guides, the Video Frame, and the Alignment Washers

Note that the indicated roll of the centerline camera changes (improved) from contact to pre-separation. However the indicated roll of the non-axial camera does not change. This difference may be attributed to the fact that the centerline camera must be removed before the Shuttle crew can enter the Mir. Before undocking, it is replaced. This removal and replacement may be relevant to the differences in indicated camera alignment between docking and pre-separation.

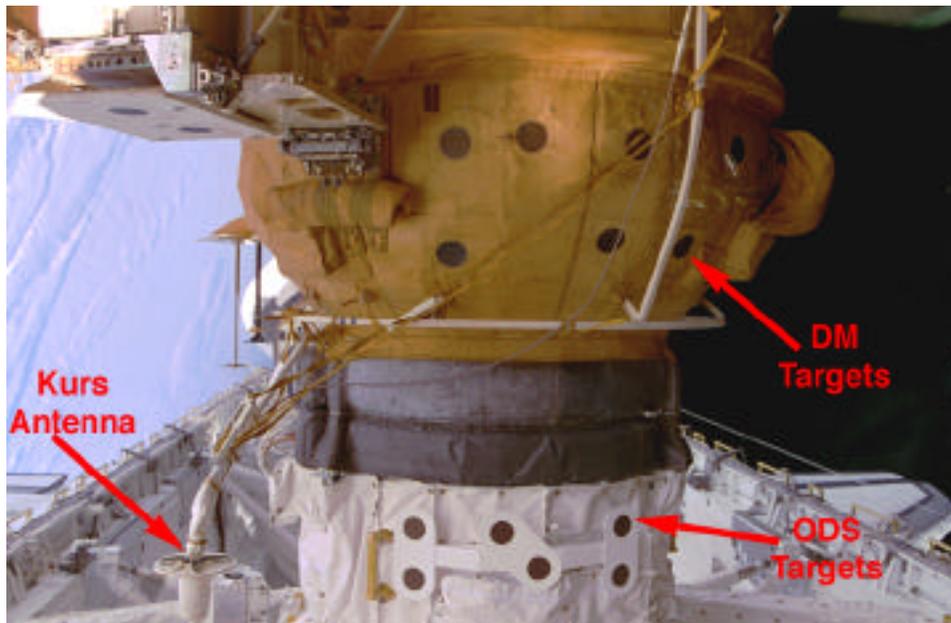
Figure 9.1 Kurs Antenna as seen from the Shuttle Flight Deck on STS-81

Between STS-79 and STS-81, a Kurs antenna was attached to the Mir Docking Module. This Kurs antenna extends toward the Shuttle forward bulkhead as shown in Figure 9.1. The JSC Structures and Mechanics Division requested that an analysis be performed to determine the position of the tip of the antenna. This information will assist the group in determining the flight clearances between the antenna and the Shuttle Payload Bay forward bulkhead.

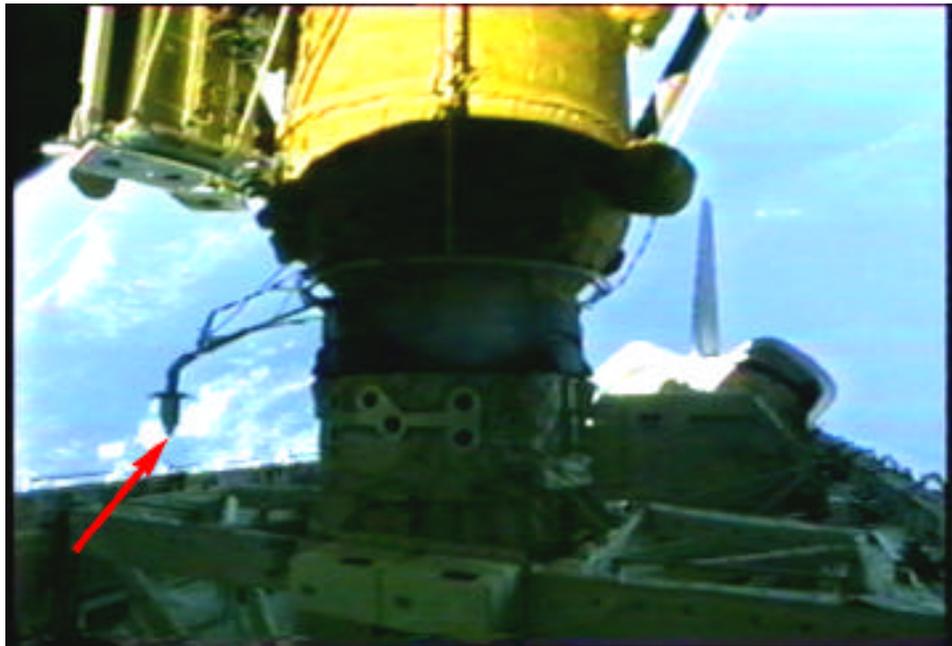
Figure 9.2 Kurs Antenna as seen from Payload Bay Camera A

Two STS-81 video images from Shuttle PLB Cameras A and D were used in this analysis. These two images are shown as Figures 9.2 and 9.3. The image coordinates of targets ODS1 through ODS6 on the ODS were determined in both images. Image coordinates were also obtained for Docking Module targets TB7 and TB8 in the video image from camera A. Other OSVS targets were not utilized due to shadows in the field-of-view. A centroid analysis of the image pixels corresponding to each OSVS target was performed to determine the image coordinates of the targets. The color video frames were first converted into grayscale images, and then binarized to perform centroid analysis on each target more precisely.

The location of the Kurs antenna tip in SSCS coordinates during STS-81 is: $X_0 = 685.5 \pm 1.9$, $Y_0 = 42.3 \pm 1.1$, $Z_0 = 439.3 \pm 0.9$ inches. The errors are 3σ values. These coordinates show a clearance of 109 inches between the tip of the antenna and the Shuttle forward bulkhead on STS-81. The expected coordinates based on data obtained from the Space Shuttle Program Integration Engineering Office are $X_0 = 683.4$ inches, $Y_0 = 40.5$ inches, $Z_0 = 439.1$ inches.
